# JESUS COLLEGE, CAMBRIDGE

## Survey and Recording of the Chapel Nave Roof

**Cambridge Archaeological Unit**  
University of Cambridge  
September 2007

CAU Report 784

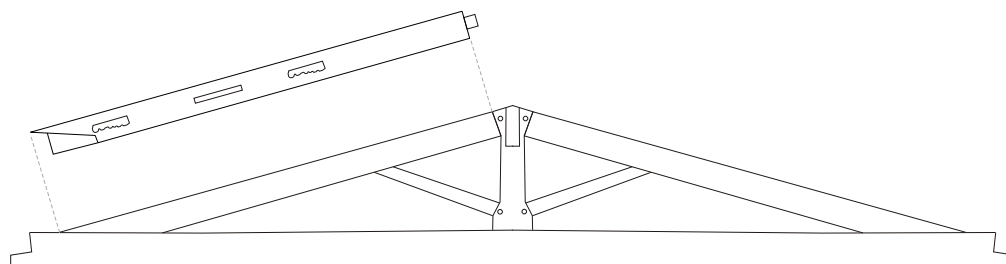
A: King post truss showing example of reused timber

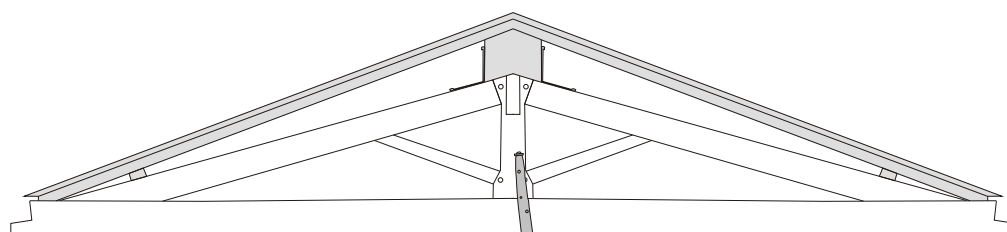
B: Addition to Master's Lodge truss to elevate the roof and alter the pitch

The roof of the Master's Lodge has a different pitch to that over the chapel. The trusses were constructed in the same way, but the pitch had been increased using a block on the top of each king post, held in place by an iron bracket each side, to raise the ridge by approximately 0.40m. A second ridge plank had been inserted by raising the purlins above the principal rafters and forming a common rafter roof. As noted above an iron strap had also been added from the front of the king post to the back wrapping beneath the tiebeam. Scars on the retained lower ridge plank show that the common rafters had been nailed to it and that both the Chapel and Master's Lodge roofs were originally the same.

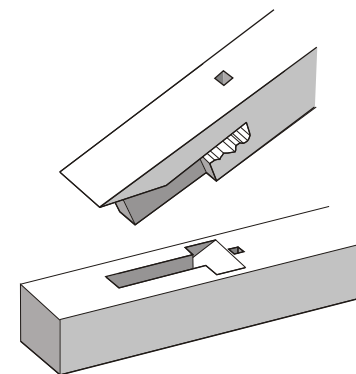
E: Detail of tenon joint fastening principal rafter to tiebeam (evidence of reused timber)

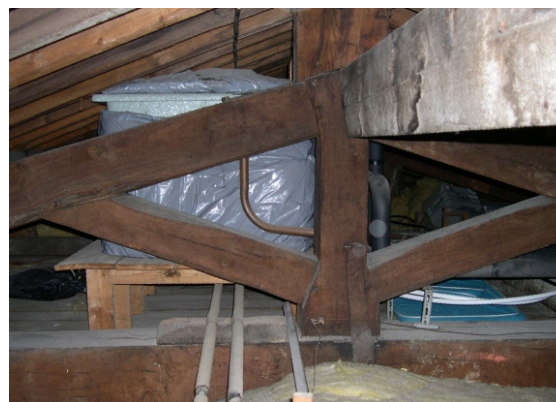
D: Master's Lodge truss showing metal strap at base and brackets securing the added block (6<sup>th</sup> truss from tower end)

When oak was used metal straps were not generally considered to be necessary to hold the tension joint at the base of the kingpost to the tiebeam, however such straps were visible on trusses within the Masters Lodge roof. Yeomans notes that straps

were not considered necessary with oak trusses (Yeomans 1992: 40). This is clearly true as there is no evidence that this joint had opened. If it were an original feature it there should have been straps on all the joints between the tiebeams and king posts. Straps are, however, much more common on pine truss roofs of the 19<sup>th</sup> century and it is probable that this is when these were added - perhaps installed by a lesser carpenter than the man who original built the roof. The raising of the Master's Lodge roof took place in the 1980s, also to address drainage issues (Alan Fosbeary pers comm.). The evidence from the similar shape of the oak trusses (the draw pegs points had been left on the trusses in similar positions) the use of a pine ridge plank, and the redundant joints for butt purlins all suggest that the king post truss roof was originally a single structure over both the chapel and the Masters Lodge. The use of reused timbers at the tower end and pegging towards the tower and wall dividing the chapel from the masters lodge suggest that the roof was built from the tower end, the presence of the peg ends 100mm long indicates that the trusses were assembled on the roof possibly upright. Had they been assembled horizontally then raised the pegs would have faced away from the tower. Had the truss been built on the ground the pegs would have been cut off before it was lifted onto the roof.

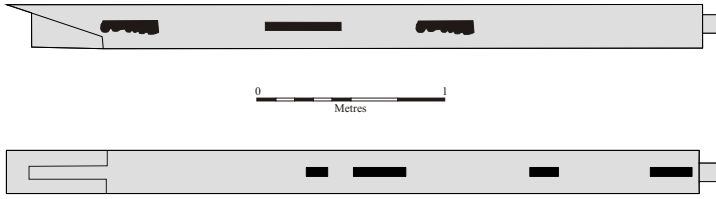
A: Moulded and plain mortice holes in reused timber (PR8)

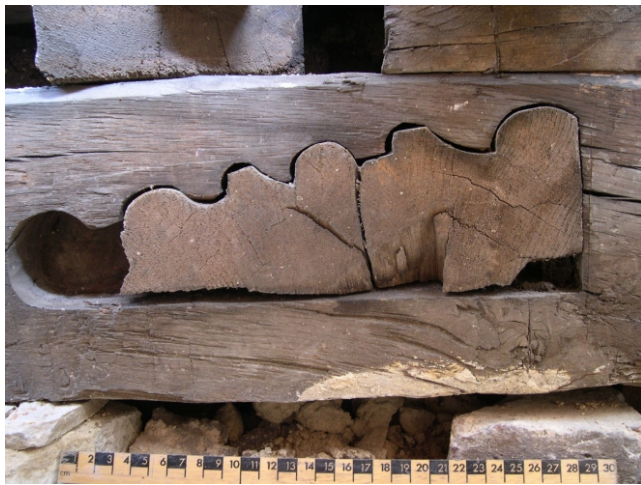
C: Sawn off remnant of moulded purlin in WP4

timber, reused in wall plate WP4, still had substantial cross sections of ogee mouldings on the face, with fragments of the beams remaining inside the housings, the beams having been sawn off flush with the face of the wall plate timber. The housing of the beam end was 320mm long and tapered from 100mm down to 55mm so that the front of the housings angled out as the rear was parallel with the back of the timber and flush with the back of the mortice. Where these joints occurred on both sides of the beams through mortices had been cut. The tenon was 370mm long by 35mm thick and 120mm deep and was held with two 21mm diameter pegs. The grain of this tenon was at an angle of forty-five degrees to the socket giving an angle to the mortice that suggests that this was the tenon of a brace (Figure 7.F). The distance from the top of this mortice to the housing above was 529mm. The lower edge of the tenon was angled which would have enabled the brace to be fitted after the structure was assembled. The front shoulder of this moulded beam was housed to a depth of 55 to 60mm. and backed by a tenon. The mortices were 210 x 60x 60mm, were parallel to the back of the beam and 92mm from it. These joints occurred on both sides of six timbers (principal rafters PR2, PR3, PR4, PR6, purlin P8 and wall plate WP4) and on one side only of four timbers (principal rafters PR1, PR5, PR7 and PR8).

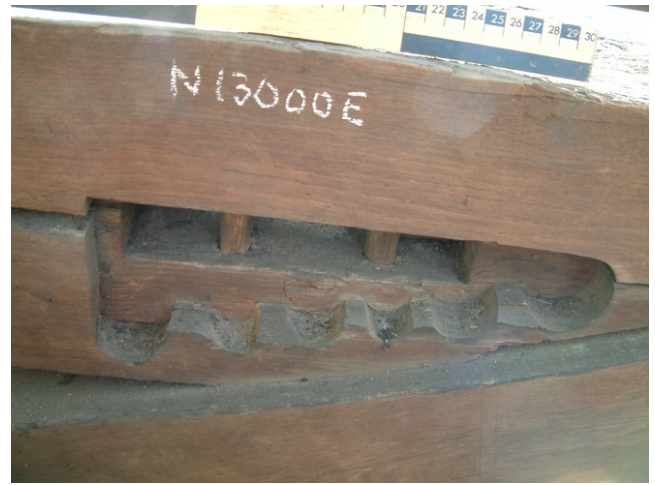
D: Empty mortice in PR6 showing moulding, slot for tenon and pegs still *in situ*

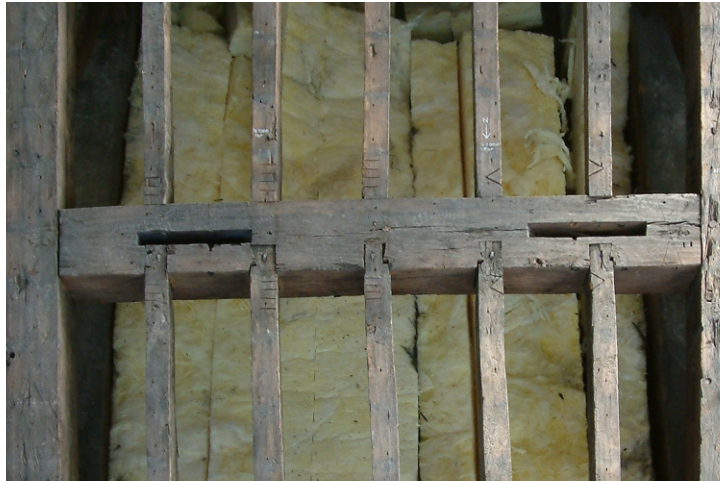
B: Group 2 timber reused as purlin P7 above compared to Group 1 timber reused as purlin P8 below

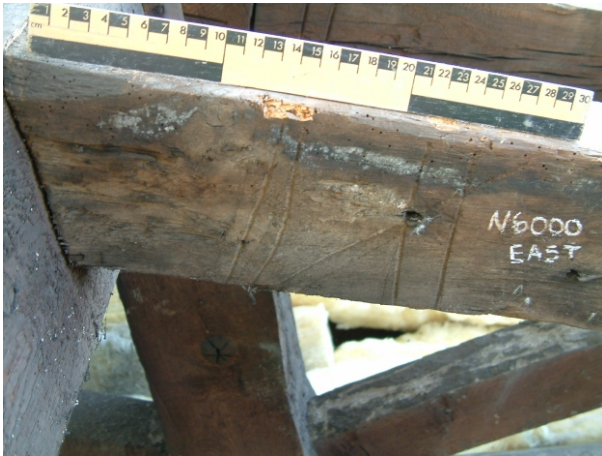
A: Race knife mark  $\parallel\parallel\parallel$  on common rafter 8R6

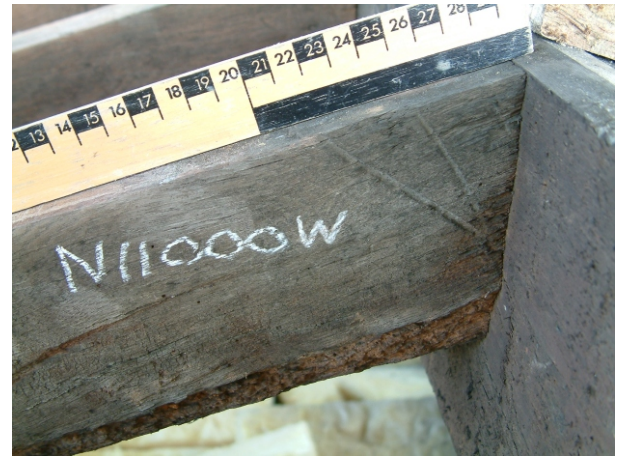
B: Truncated race knife mark  $\diagdown$  on common rafter 2R7

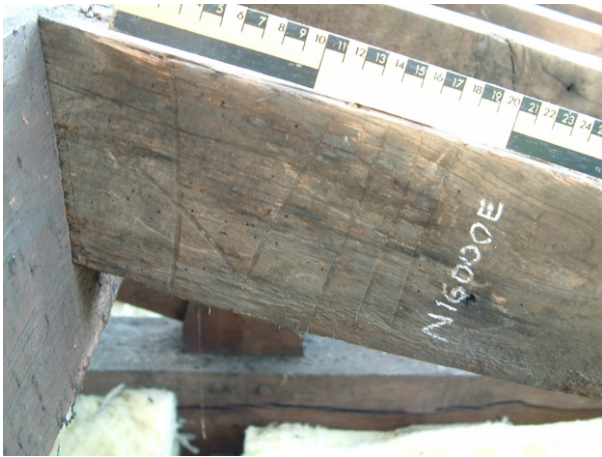
C: Race knife mark  $\diagdown\diagup\diagup$  on common rafter 6R8

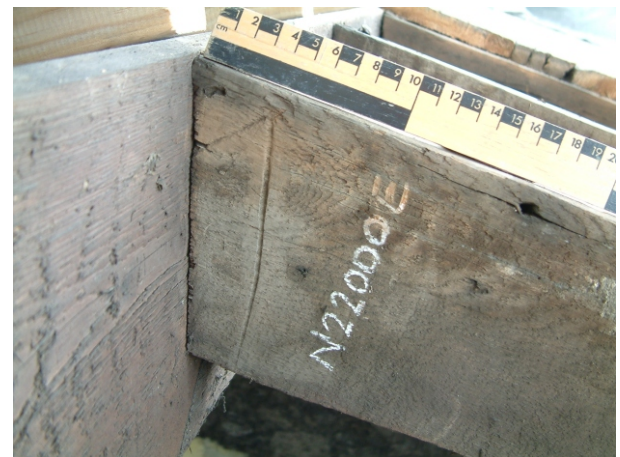
D: Race knife mark  $\diagup$  on common rafter 5R7

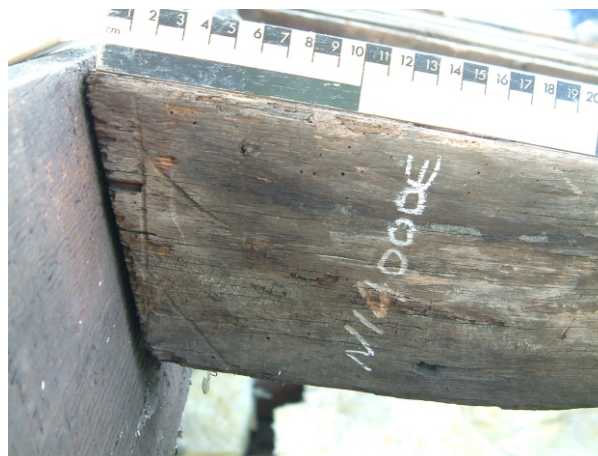
E: Truncated race knife mark  $\diagdown$  on common rafter 6R10
