INVESTIGATIONS AT
THE GATETOWER AND WEST RANGE
OF JESUS COLLEGE,
CAMBRIDGE

Cambridge Archaeological Unit
University of Cambridge
April 1998

Report No. 253

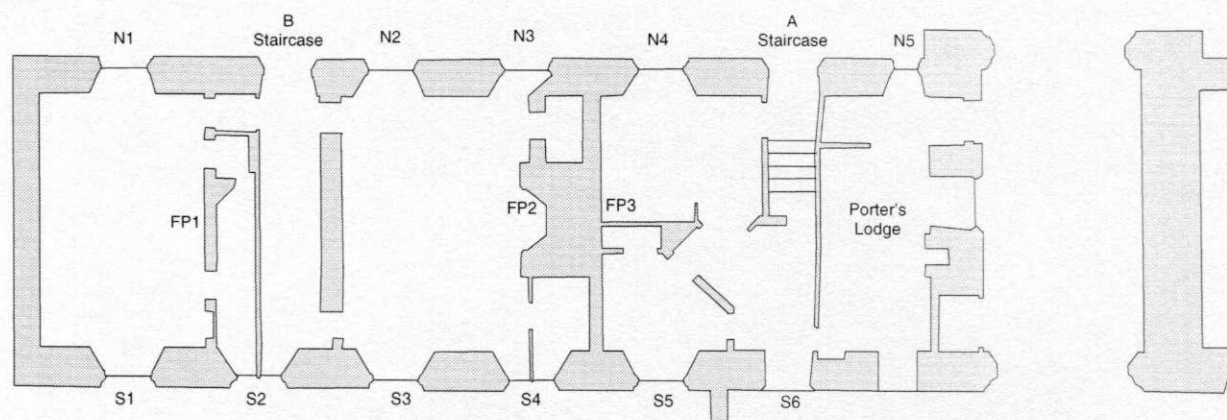
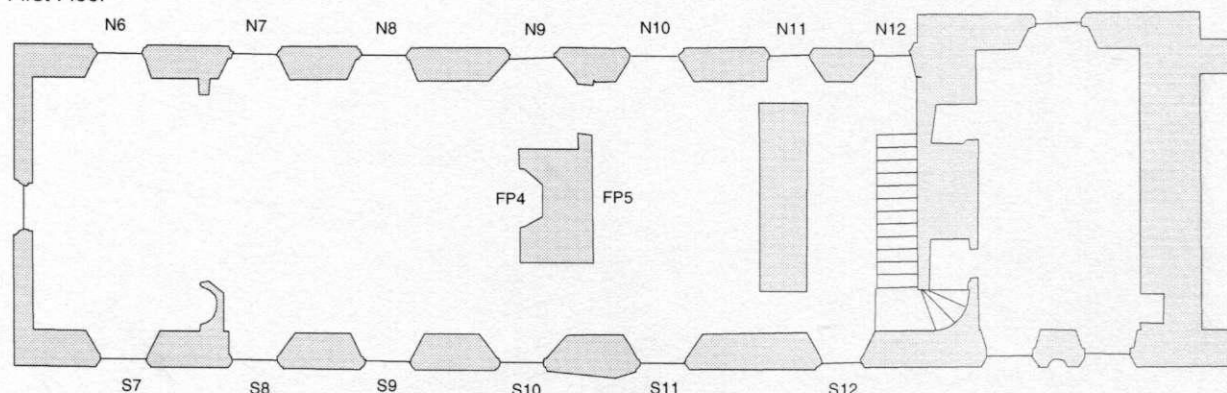
Figure 2 Ground and First Floor Plans Showing Window Numbering Scheme

To distinguish between elements of the structure (i.e. windows etc.) these have been numbered as shown on figure 2. In summary these are:

Windows:	S.1 - S.12	South wall windows ground and first floor
	N.1 - N.2	North wall windows ground and first floor

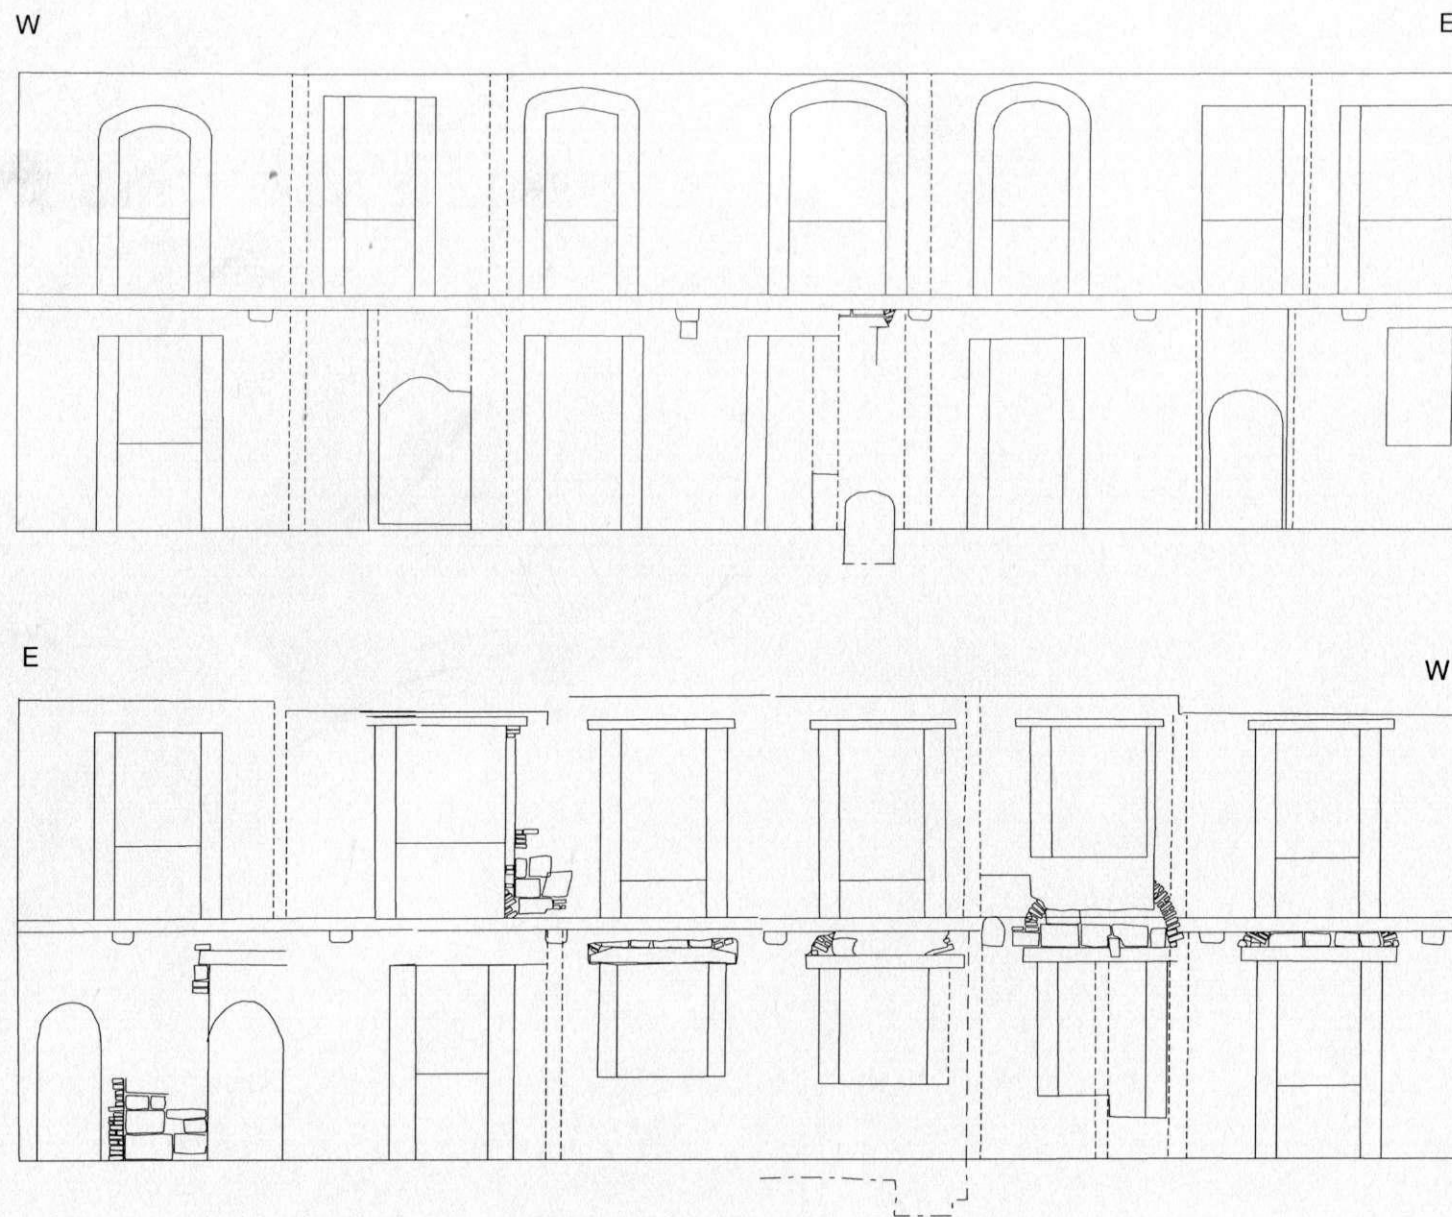
Figure 3 North and South Internal Elevations of the Grammar School Range

At present there are ten windows in the south wall (S.1-5 on the ground floor, S.7-12 on the first). In addition there is S.6 on the ground floor, now an internal doorway, and the opening in the southwest corner, un-numbered, which is in more or less the same place as a small window on Loggan's 1688 print, and a similar window above it on the first floor. The north wall has five windows (N.1-5) and two doors on the ground floor, seven windows on the first floor (N.6-12). Observation suggests that all the windows have been much altered.

The original form of the first floor windows is more difficult to determine. All the south wall windows had flat lintels but these were formed from much slighter reused wooden beams in sets of three, some of which had been replaced with modern concrete. The only case where wall fabric was exposed, above S.7, showed a single course of bricks laid on bed, and which may well relate to the second floor extension rather than the window construction. It is apparent that the first floor windows were also originally half bay. Some are now lengthened to full and these extensions have cut through the relief arches of the ground floor windows below (S.7 through S.1, S.9 through S.3, S.10 through S.4, S.11 through S.5 and N.9 through N.3). Four of the first floor windows in the north wall have a different construction (N.6, N.8 N.9 and N.10). The tops of these are arches built entirely in brick, sloping

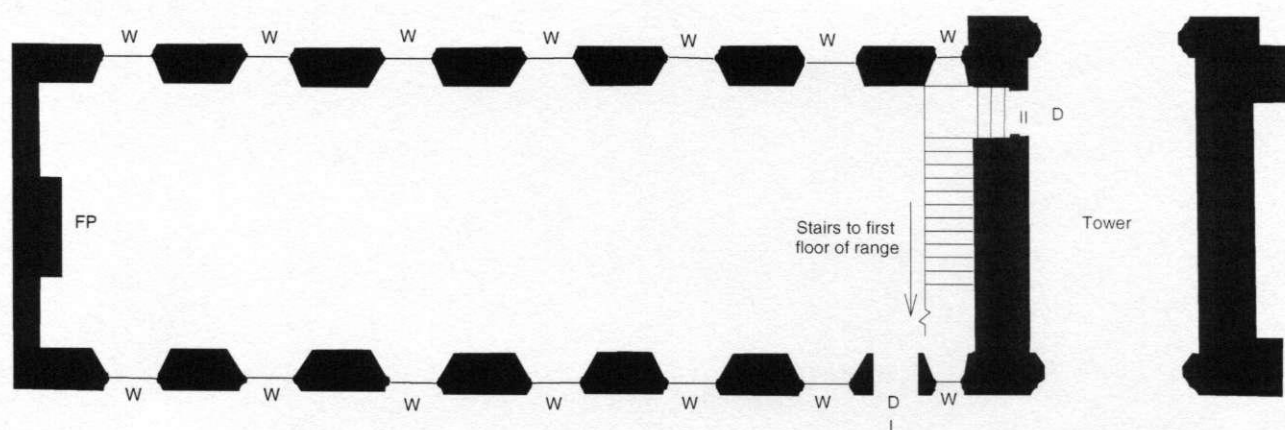
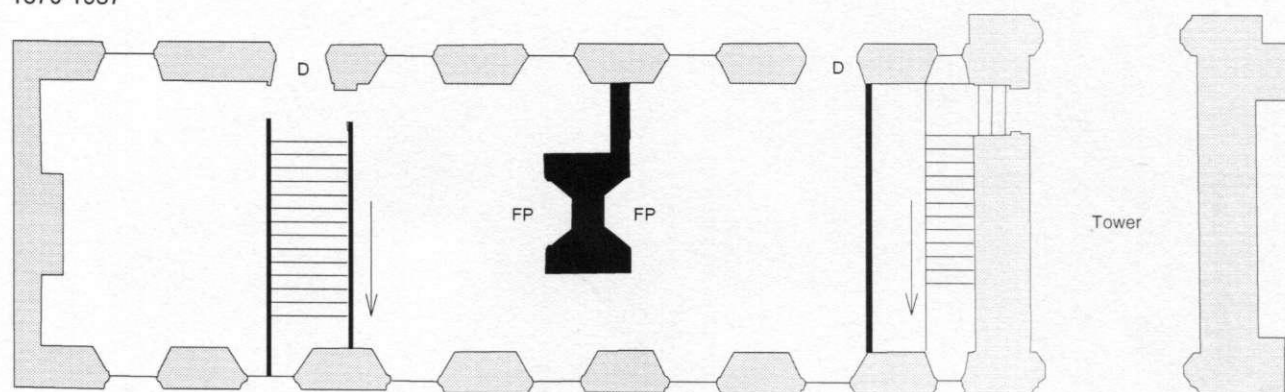
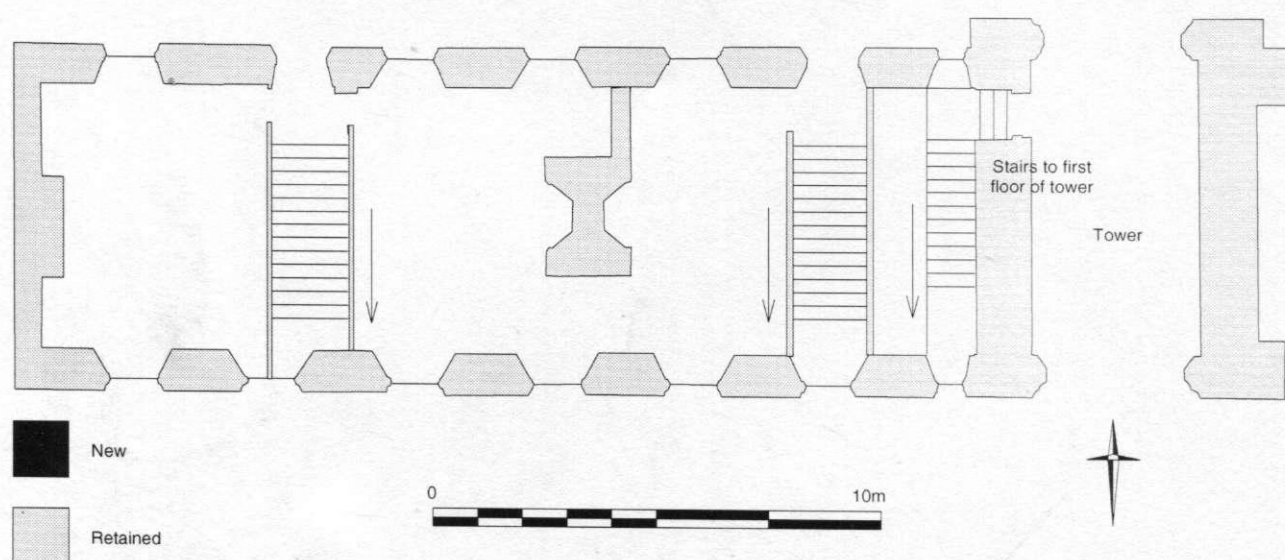
Figure 4 Proposed Ground Floor Layouts Within the Grammar School Range

School Range in its earliest form, although one must have existed. Inference, however, can be made from the floor plan. The proposed ground floor layout at this period (see figures 2 and 3) is for seven opposed pairs of windows on the north and south sides. The two easternmost windows, however, are significantly smaller than the rest there is also the suggestion, described above (see *external walls*), of the possibility of a doorway between window S.6 and the southeast window. These features suggest that the east end of the Range was different to the pattern of the rest. Combined with the form of the doorway in the east wall (the Porter's Lodge door, see below) it is possible to suggest a primary wooden staircase rising directly from the east door to the first floor of the range, entrance to the school itself being through the proposed southern doorway, thus separating the function of the School from the function of the College proper.

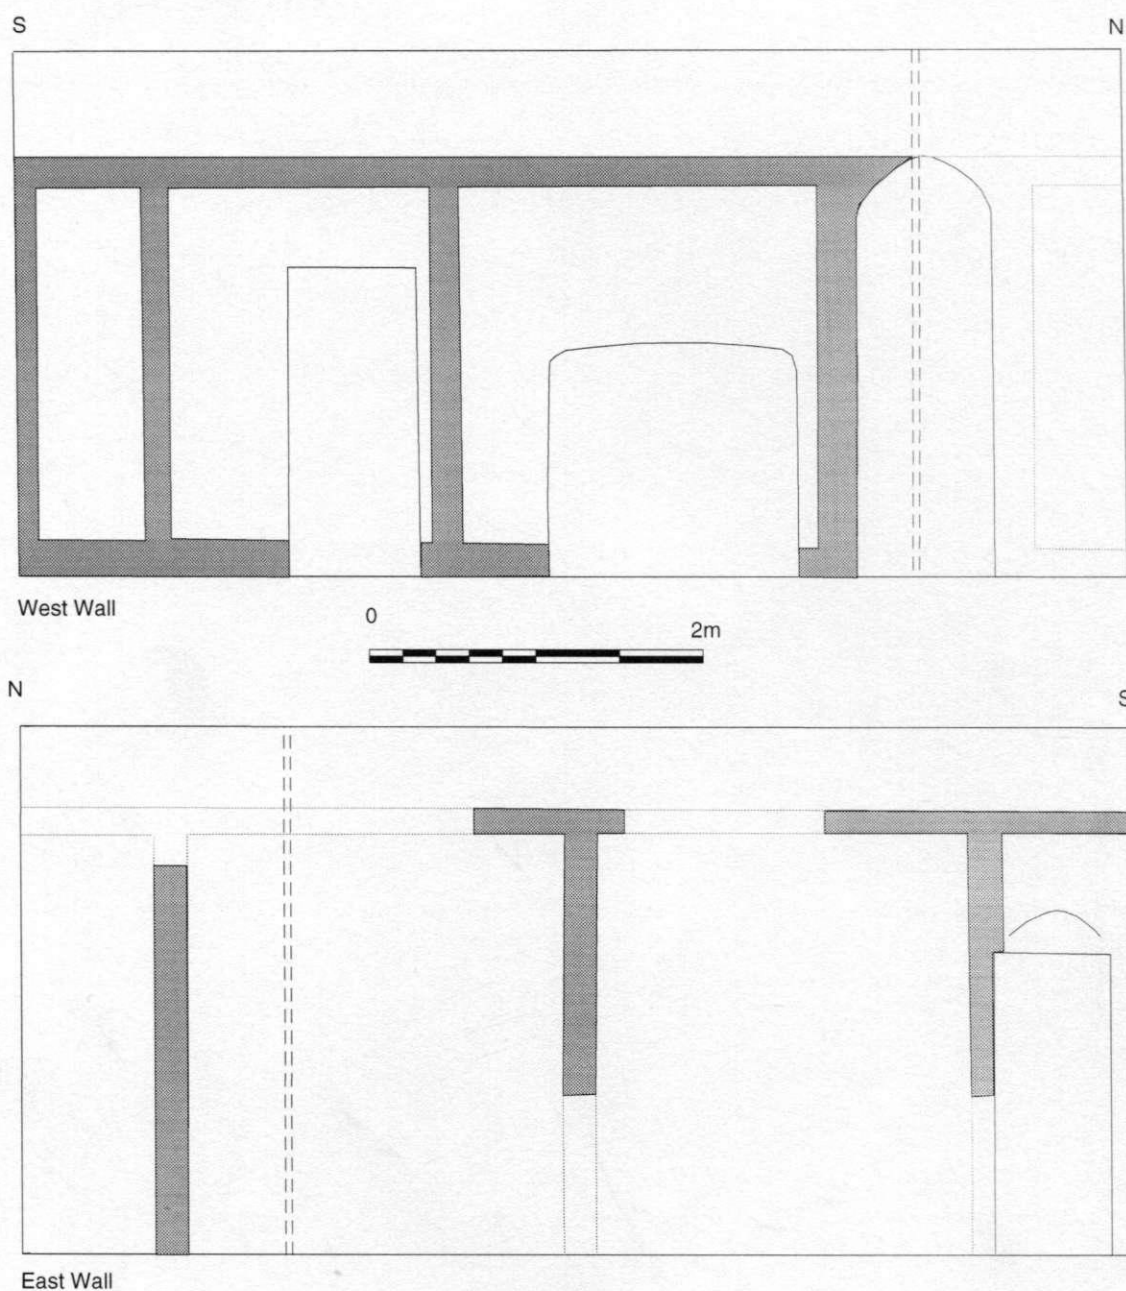
Figure 7 First Floor Room, Gatetower (Schematic)

The first floor tower room was evidently of some status and has retained evidence of several phases of its use and decorative schemes. Beneath the later panelling, which also served to divide the room into two unequal parts, survived an extensive painted decoration. This consisted of broad green bars (180mm wide) with black borders dividing the walls into panels (approx. 2.20m x 0.64m). The background and infill of the panels are painted white. Traces of either an earlier paint scheme or undercoat for the green and white scheme is visible as traces of black and salmon pink. The green paint scheme respected all the doorways, which may suggest that all were still in use. This would give a date of pre-1637, which is not inconsistent with the copper based paint used. The conservation report on the paintwork, however, suggests that the scheme is more likely to be a little later, perhaps late 16th, early 17th century (Appendix 2). Archaeological evidence does not serve to elucidate the question further. On top of the paint work there are trace of wall

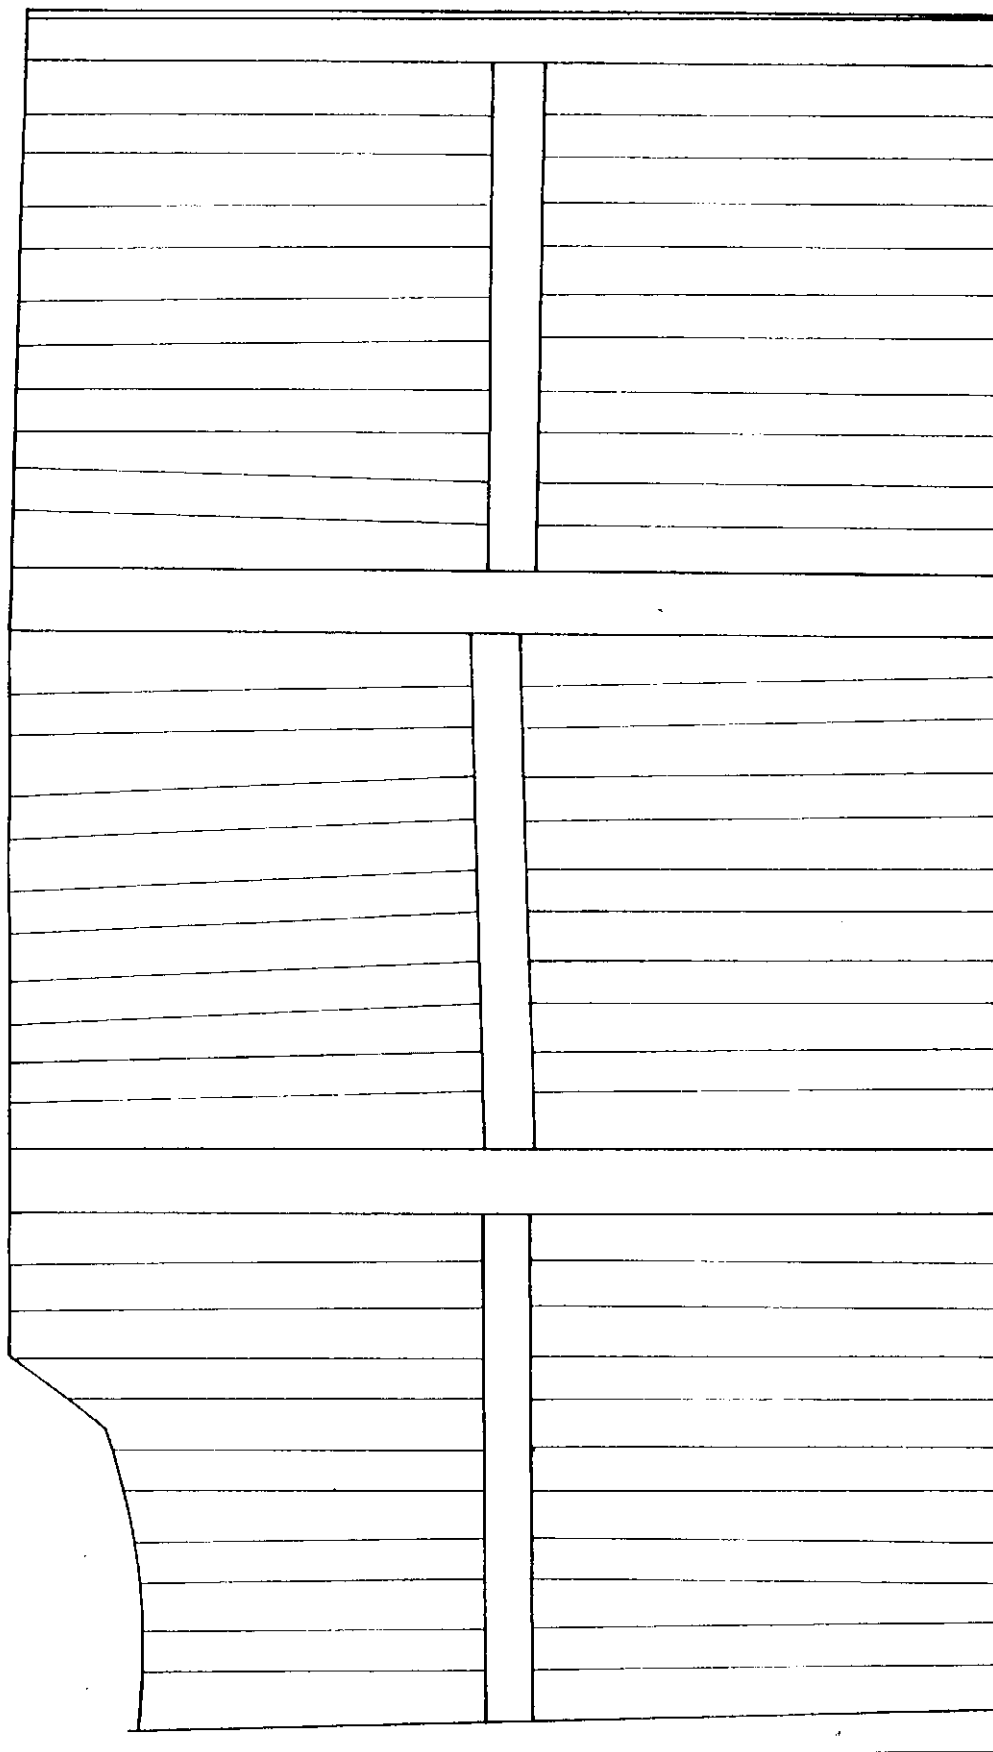
Plan
CHBG

The roof is of oak and its length is divided into three structural bays by two cambered tie beams which are matched by similar beams against the end walls. Along the central axis there are secondary beams which divide the roof into six compartments and in each of those there are five rafters. The only irregularity is at the south end of the west side where the newel stair leading up to the parapets intrudes into the room.

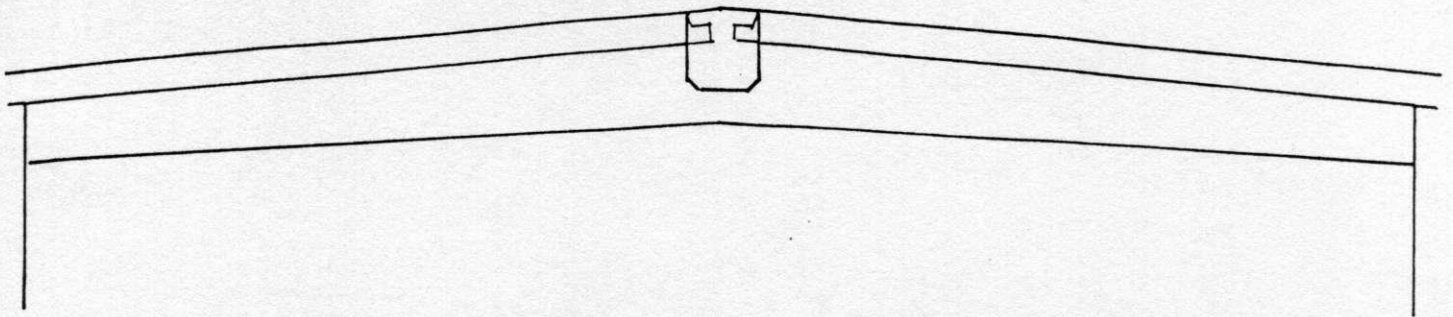
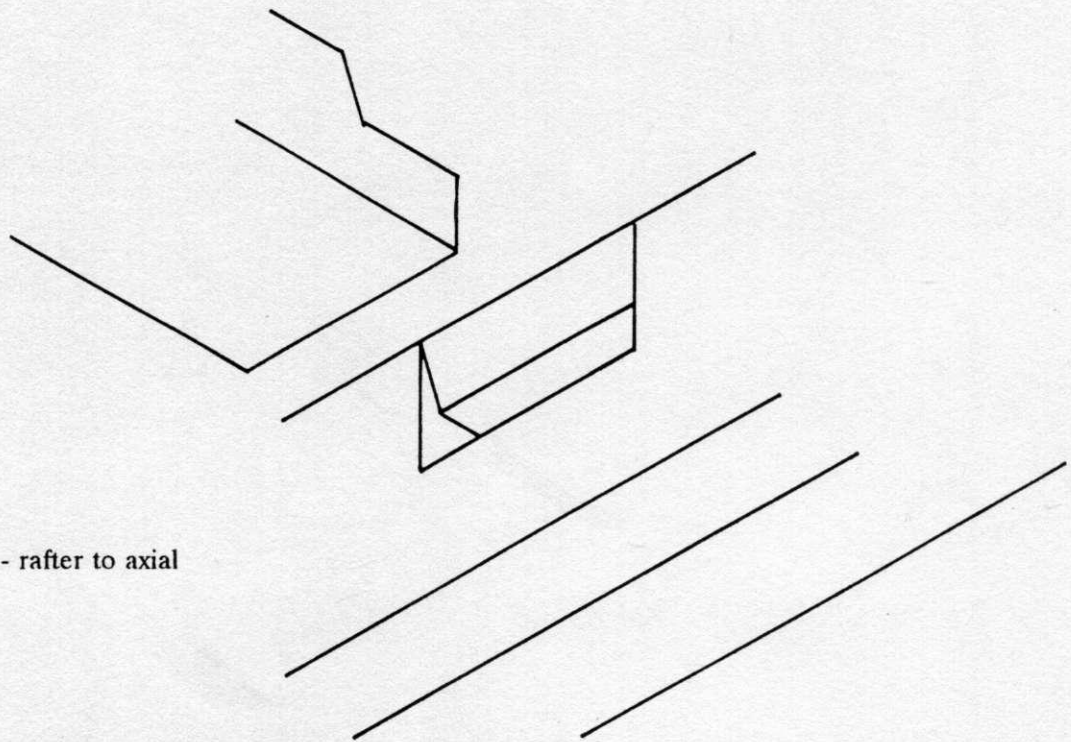
Section
Details
CHBG

The tie and axial beams have plain chamfers with hollow stops and it is clear that the underside of the roof was intended to be seen from the tower room. The timber was probably left in its natural state but it was later covered with a thin layer of limewash some of which survives although now grey in colour and flaky.

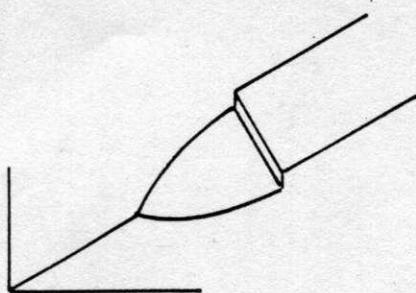
Joint - rafter to axial

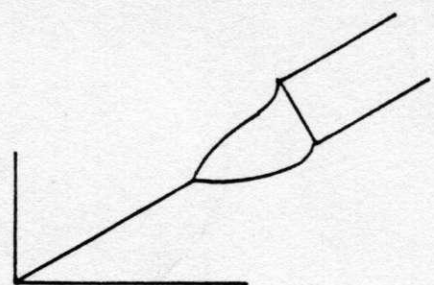
Stop on original tie beam

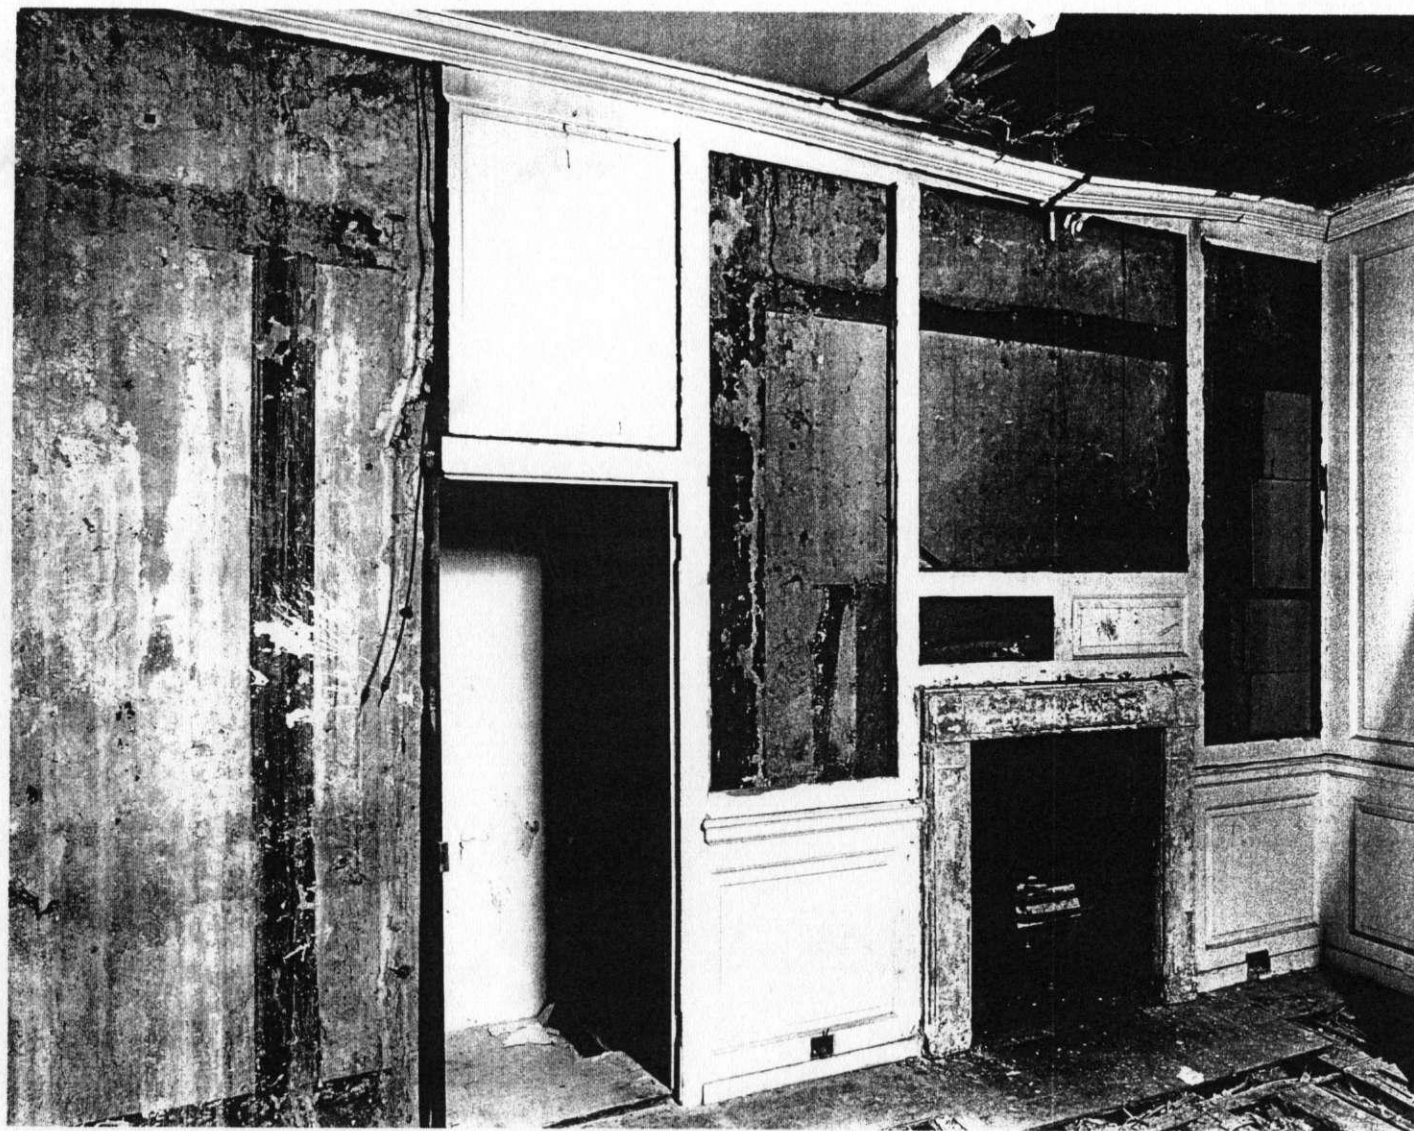
Plate 1 Gatetower Painted Room, West Wall
(Courtesy of RCHM)

The painted decoration consisted of a series of thick green lines (approx. 180mm) with black borders (approx. 8mm) separating the wall into panels (approx. 220mm x 640mm). The background and infill of the panels were painted white. Visual examination of the green paint suggested that it was copper resinate or a similar synthetic cuprous pigment.

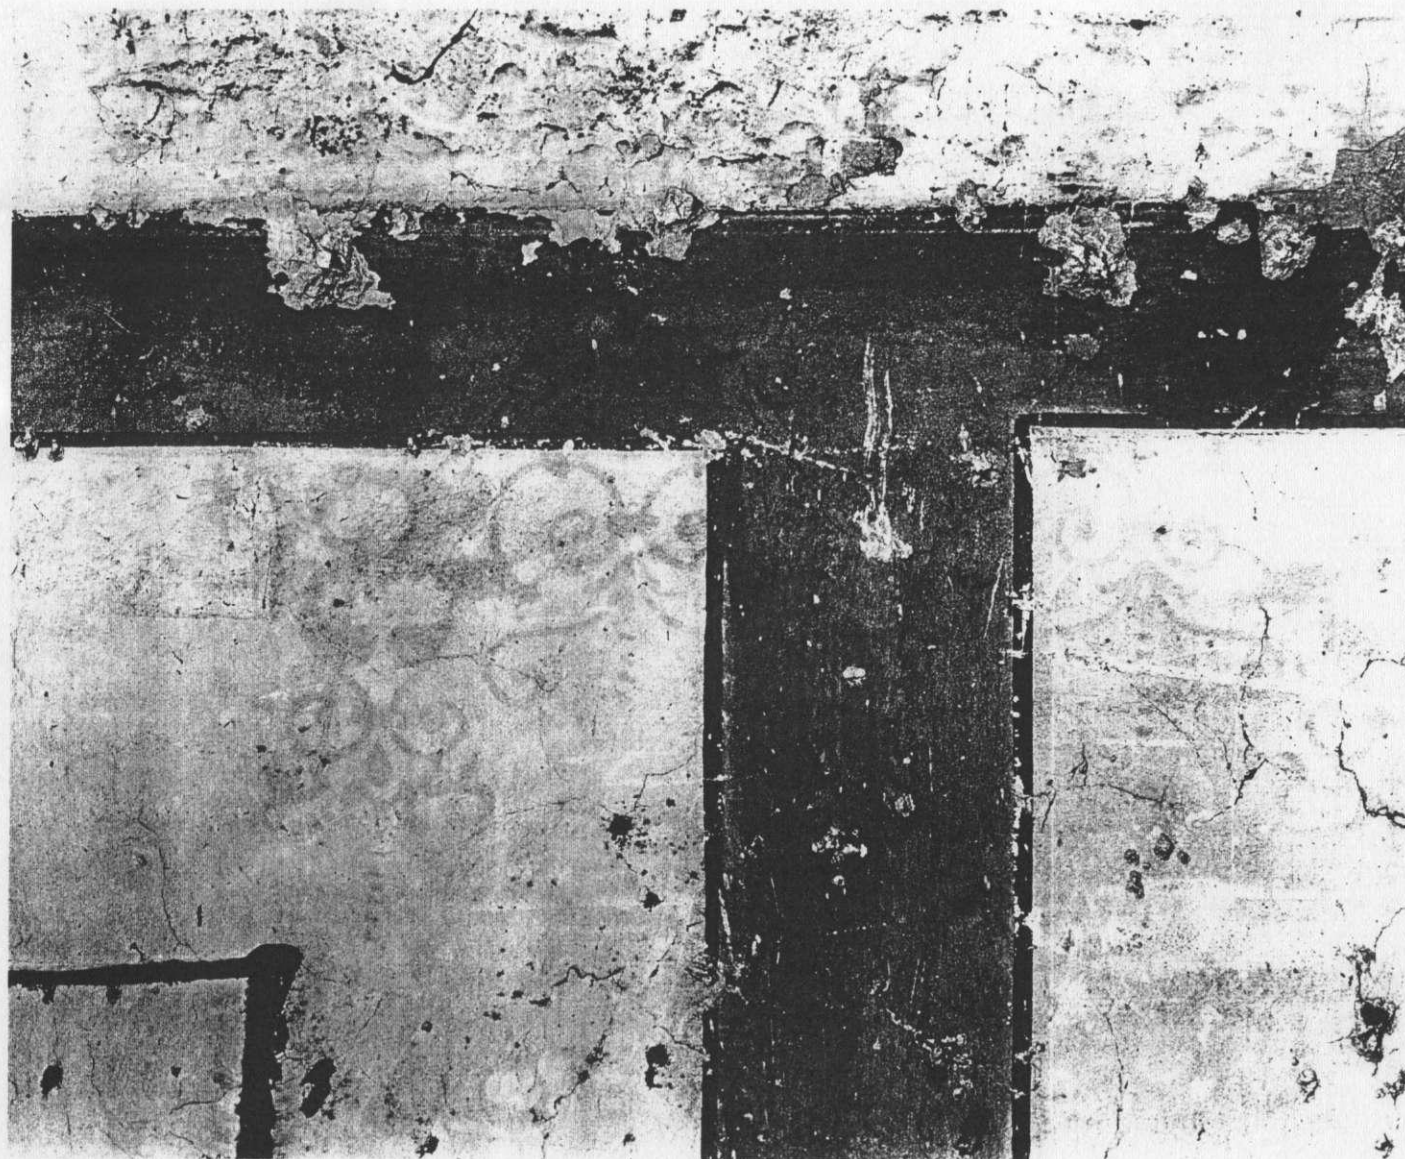
Plate 2 Gatetower Painted Room, East Wall, Detail
(Courtesy of RCHM)

On the east wall, areas of a very faint linear arabesque decoration was observed on the upper part of one of the white panels. No pigmented material was apparent and it appeared likely that this was part of a decorative scheme which was not associated with the main painting. The most probable explanation is that the decoration had been transferred from a later wallpaper, possibly as a result of the leaching of some of the organic dyestuffs used in the wallpaper. Fragments of a wallpaper with a similar design were found in the north west corner of the room.

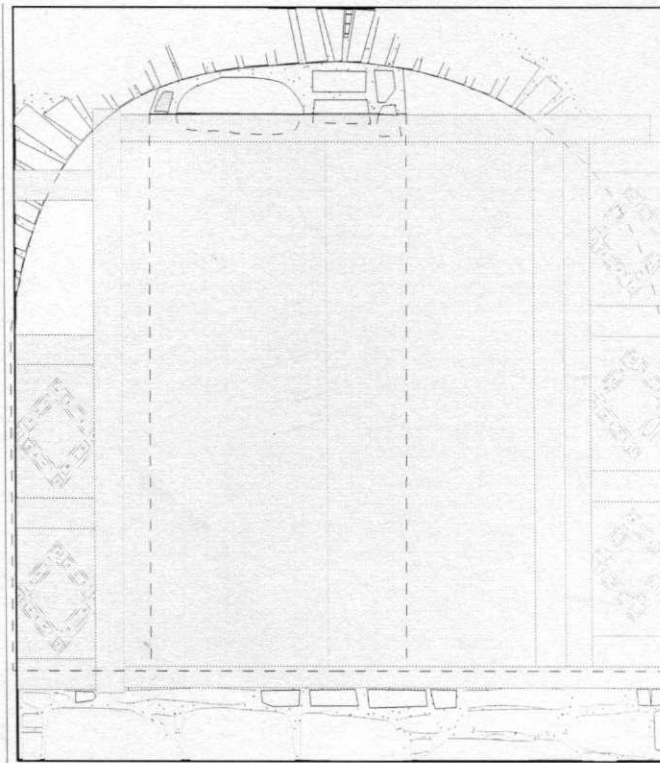
Detail of niche with later cupboard

The west wall still carries large patches of early plaster rendering which continue across the frame of the recess and into its interior. Faint traces of paint survive locally both within the recess and on the wall itself. In the back of the recess the top of a rectangular opening could be made out in the gap between the arch and the cupboard. Measuring 0.70m wide, this is off-centre within the recess and has been infilled with clunch rubble and yellow brick. The blocking post-dates the plaster as this also faced the southern side of the rectangular aperture. The render pre-dates the cupboard.

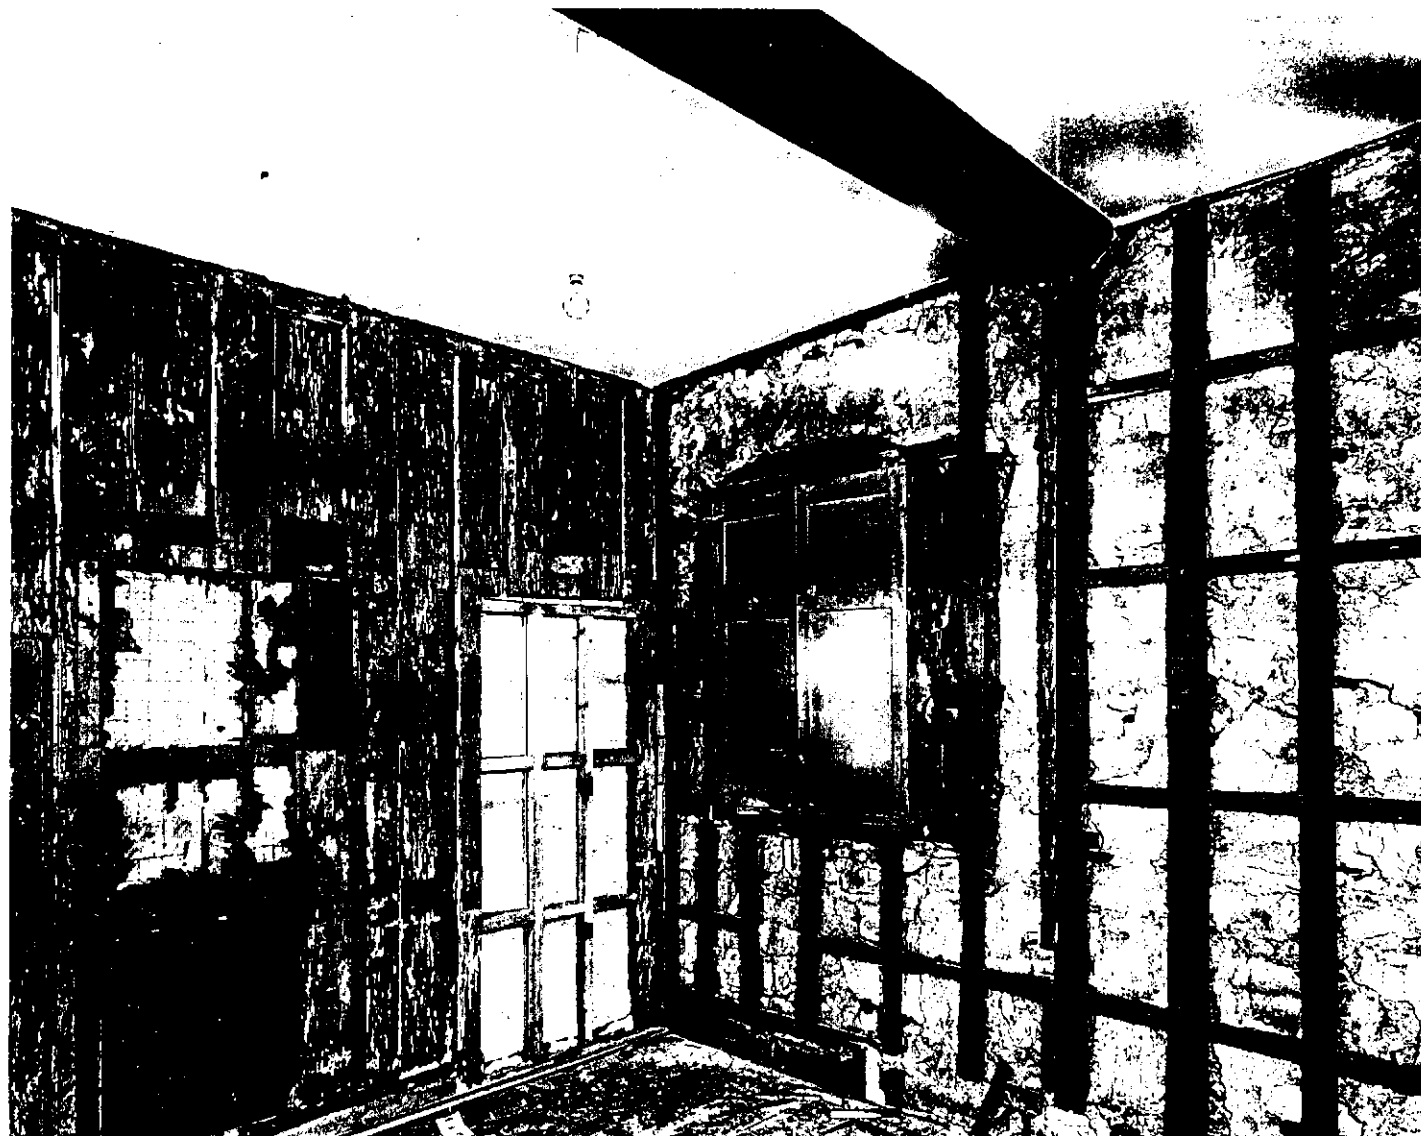
Plate 3 Master's Lodge Niche and Later Cupboard
(Courtesy of RCHM)
