# JESUS COLLEGE, CAMBRIDGE

## Survey and Recording of the Chapel Nave Roof

**Cambridge Archaeological Unit**  
University of Cambridge  
September 2007

CAU Report 784

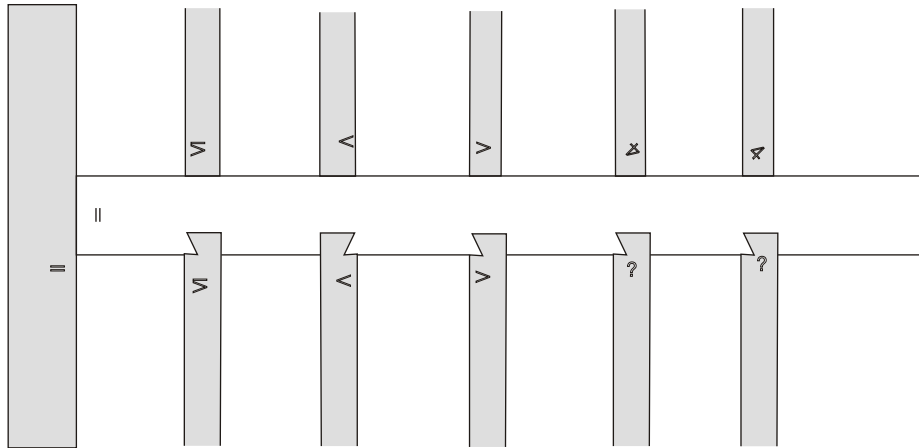
A: Common rafters between PR2 and PR3 (section 2). Note that the numbers are placed symmetrically facing each other in groups, but that the dovetail laps are not symmetrical. The '4' is actually a V with a line across it.

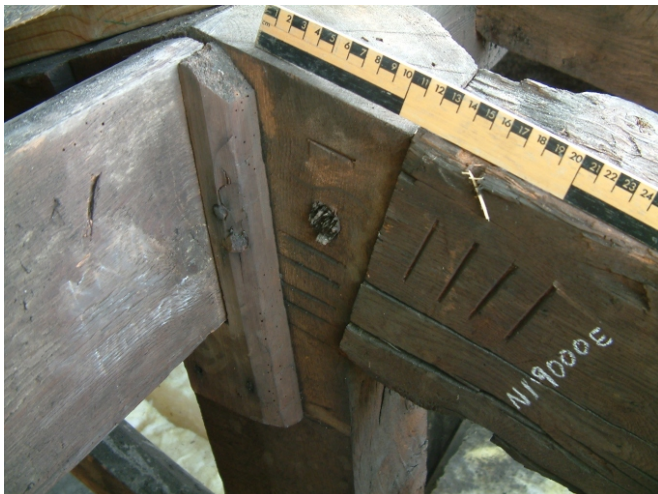
B: Marks where principal rafter PR4 meets king post KP4

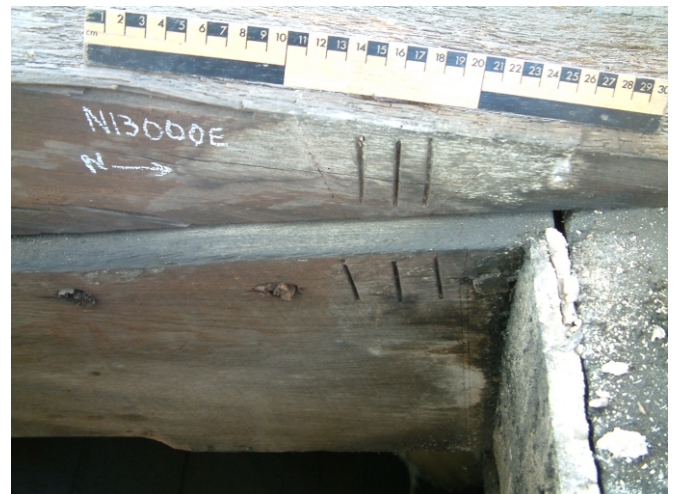
C: Marks where principal rafter PR3 meets tiebeam TB3

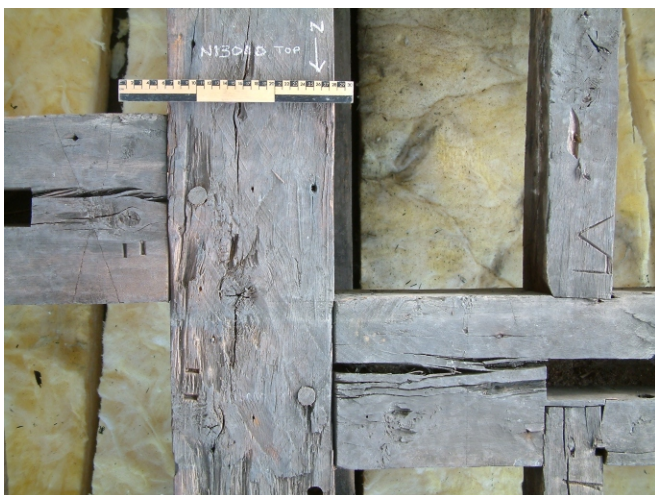
D: Marks where purlins P6 (rhs) and P7 (lhs) meet principal rafter PR6

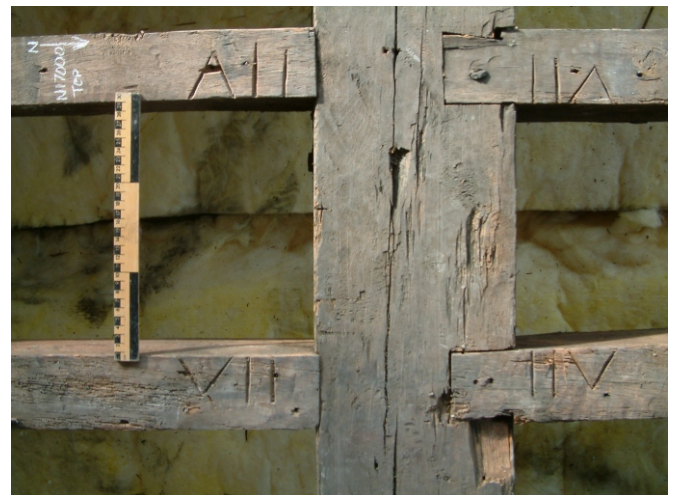
E: Common rafter marks in section 6 (6R7, 6R8 to left, 6R4, 6R3 to right)

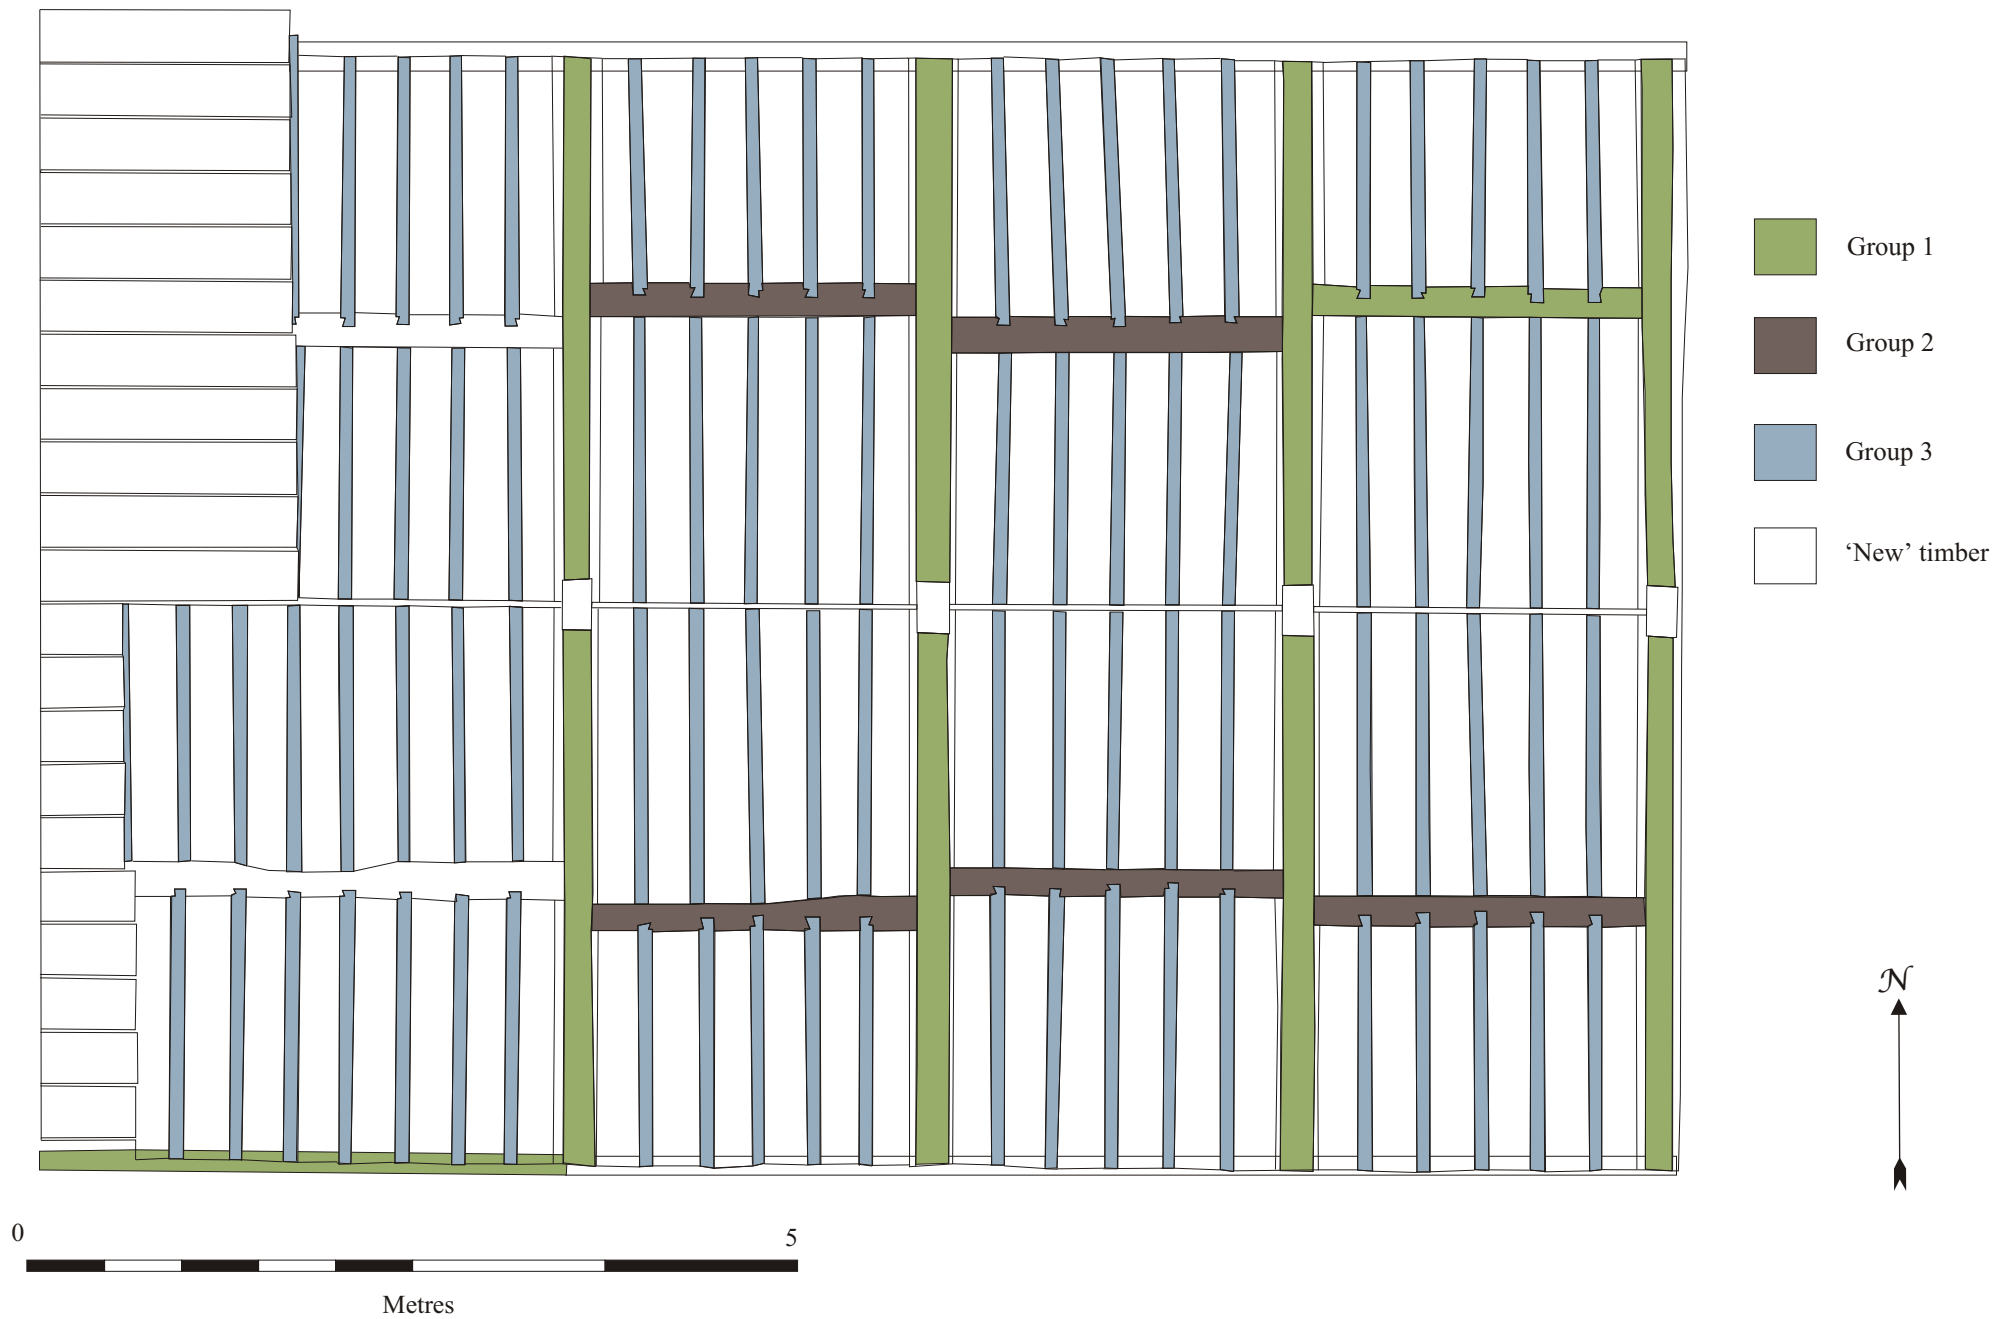
Figure 6: Location of reused timbers

- Truncated housings
- Auger holes for pegs cut through,
- Truncated carpenter's numbers,
- Re-hewn and planed surfaces
- Broken *in situ* tenons damaged by hewing across the grain.

Based on these observations three groups of earlier timbers were identified:  
(Figure 6)

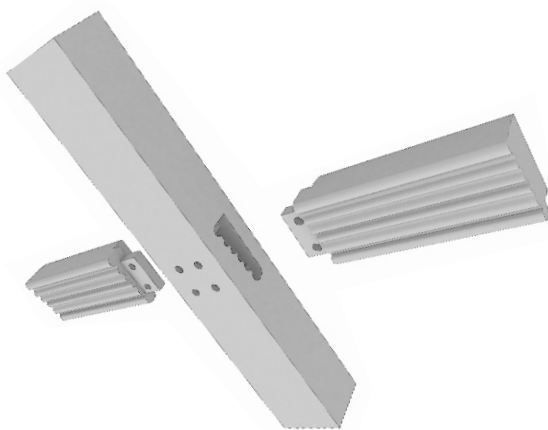
E: Reconstructed joints of moulded purlin

The joints from the eight principal rafters, wall plate, and purlin P8 were identical, each having two housings scribed and carved to fit around moulded timbers, originally 60mm deep. These housings had flat bottoms cut by the mortices housing the later tenons on the ends of the timbers. The earlier tenons had all been pegged with pairs of pegs and where the sawn off timber survived *in situ* the face was moulded. This face was angled so that the upper end of the moulded surface was 50mm nearer a face (soffit) of the timber. These joints occurred on two sides of six

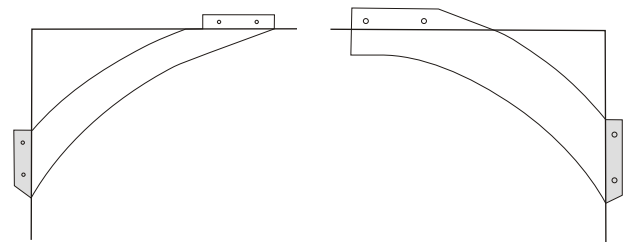
F: Alternative brace arrangements based on the plain mortice holes

On each of these timbers one of the faces at 90° to those with the moulded mortices is a second set of plain mortices. These would appear to be designed to house bracing forming each pair of principal rafters into a truss. The suggested reconstruction (Figure 8) uses a pitch angle of between 55 and 60° based on that suggested by the angle at the top of the wide tenon housing the collar brace.

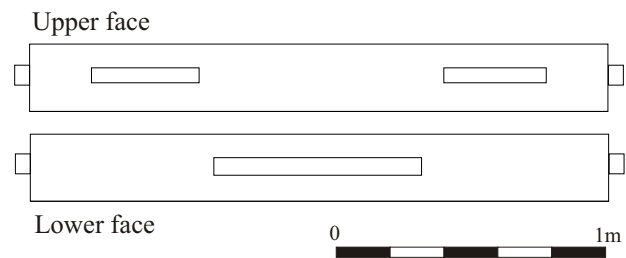
Initially it was explored as to whether the five Group 2 timbers could actually be collars within the Group 1 roof. Although there are five such timbers and the Group 1 roof could have had five collars, the pattern of mortice holes on the Group 2 timbers suggests that they actually come from a different structure. The pattern of a central long mortice below and two mortices above indicates an arrangement of braces, each with angled ends indicating the direction of the braces, like that shown in Figure 10.C. It would not be possible to incorporate such an arrangement into the reconstructed Group 1 roof either within or between the trusses. It is most likely that the Group 2 timbers are purlins from a different roof, although probably still within the college.

A: Group 2 mortice arrangement

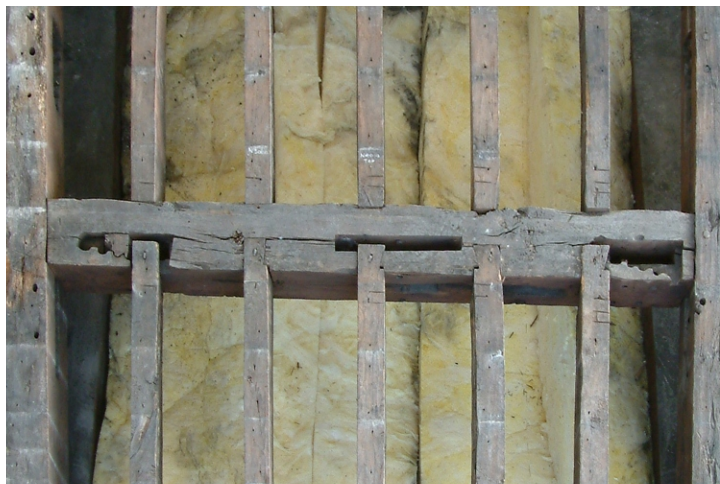
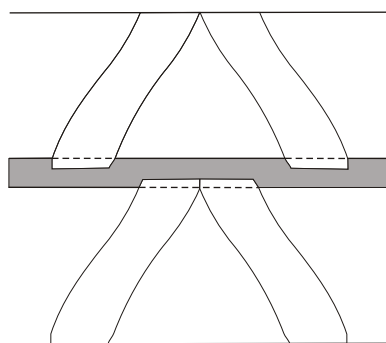
C: Brace pattern indicated by mortice arrangement in Group 2 timbers

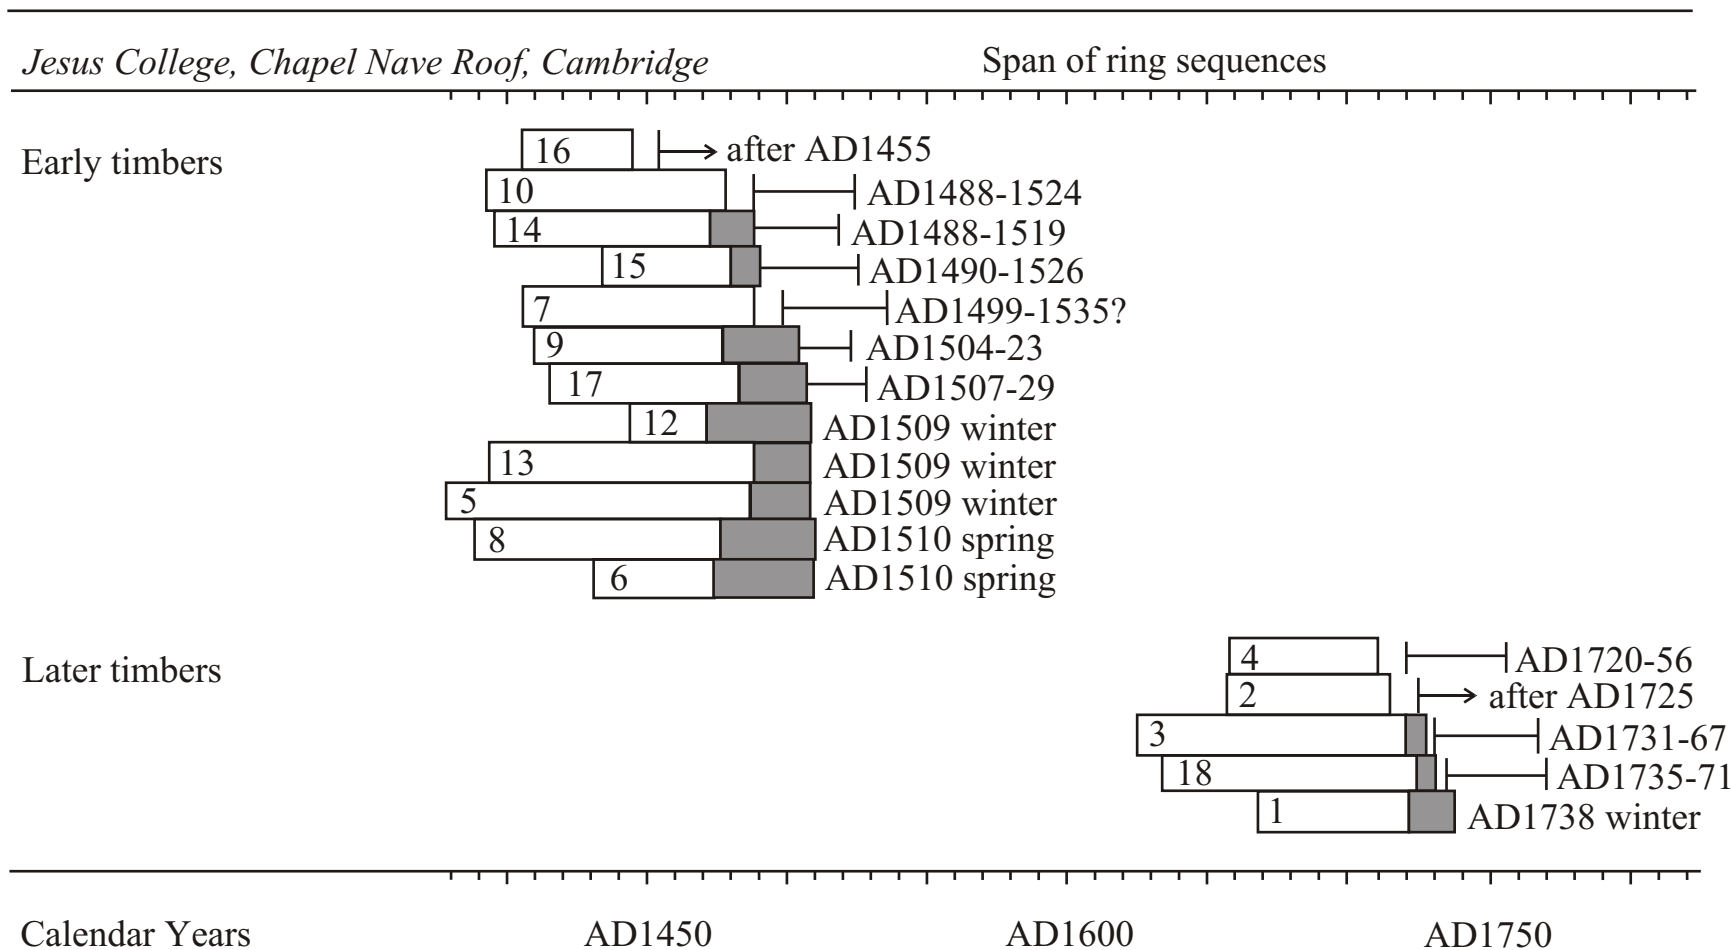
All of the dated samples are from either the primary structure of the extant roof or the re-used timbers within it. The sequence dated AD1625-1738 comprised samples from three king posts (KP1, KP3, KP4), a tiebeam (TB4) and a purlin (P4) and includes a king post with surviving bark-edge (KP4). This timber was felled in the winter of AD1738, another king post (KP1?) was derived from the same tree. Felling date ranges could be calculated for the other three dated samples in this group by adding the minimum and maximum likely numbers of rings of lost sapwood to the date of the last heartwood ring for each of these samples (see Table 2 and Figure 13 for details). These calculations are superfluous given the precision obtained from the king post sample.

The sequence dated AD1379 to AD1509 comprised samples from two principal rafters (PR5, PR8), three purlins (P2, P3, P6), and seven common rafters (1R10, 2R2, 5R2, 5R7, 6R6, 6R7, 8R10). Five of these samples had surviving bark-edge (PR5, PR8, 6R6, 5R2, 8R10), and each of these was felled in the winter of AD1509 (the two principal rafters and common rafter 8R10), or spring of AD1510 (common rafters 5R2 and 6R6). Felling date ranges could be calculated for the other seven dated samples by adding the minimum and maximum likely numbers of rings of lost sapwood to the date of the last heartwood ring for each of these samples (see Table 2 and Figure 13 for details). These calculations are superfluous given the precision obtained from the other five samples.

Figure 13: Bar diagram showing the relative and absolute positions of the dated samples from Jesus College, Cambridge.  
 (White bars represent heartwood, shaded bars represent sapwood. The felling date, felling date range, or *terminus post quem* date is also shown for each sample as appropriate)
